National Transportation Safety Board

Natural Gas Pipeline Accident Manhattan, New York March 12, 2014

Manhattan, New York (Harlem)

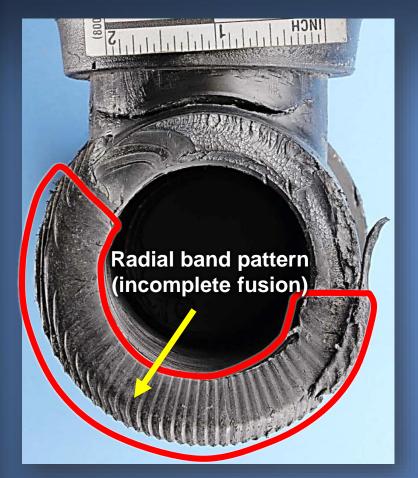
Service Tee Fracture Face

- Radial band pattern (60%)
- Is incomplete fusion
- Is a weld defect
- Weak bond strength
- Caused by contamination or inadequate surface preparation before fusion welding

- Large hole in the sewer dated back to 2006
- Service tee to gas main weld not properly cleaned – lack of fusion
- Supporting soil under the plastic gas main washed into the damaged sewer for many months

- City of New York Improve sewer main integrity process
- Consolidated Edison Revise plastic pipe fusion procedure
 - Cleaning methods
 - Improve final visual inspection

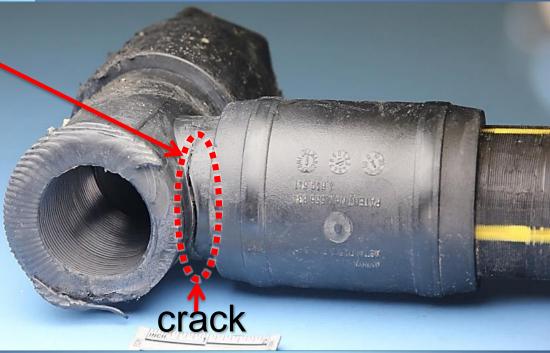
Service Tee – Crack at Outlet

- No evidence of pre-existing crack
- Rapid loading event from post-accident excavation
