National Transportation Safety Board

Natural Gas Pipeline Accident Manhattan, New York March 12, 2014

Manhattan, New York (Harlem)

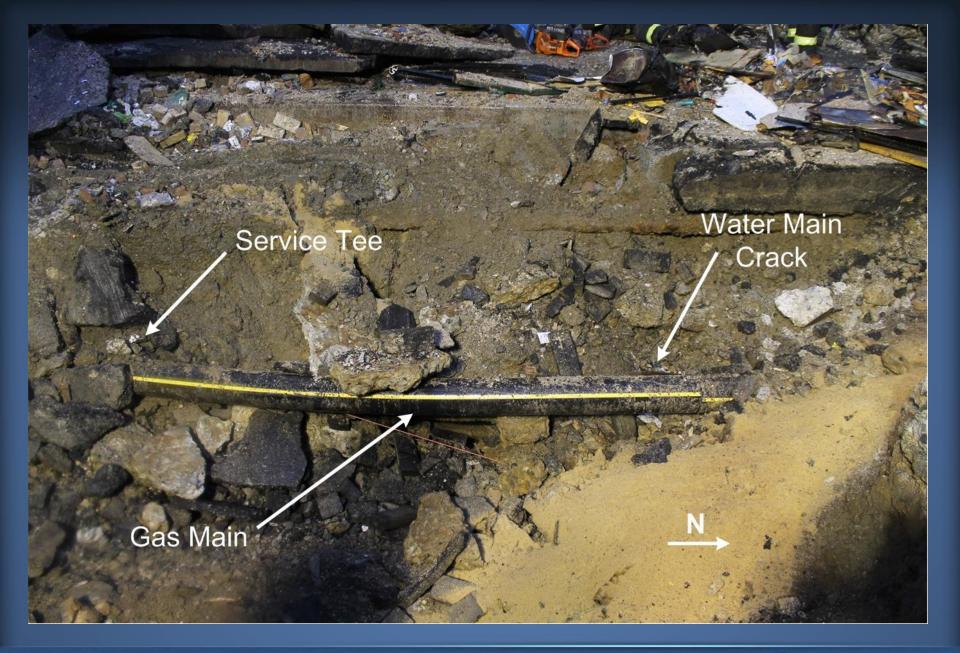
2014 Sewer Main Damage

- Large hole in the sewer dated back to 2006
- Service tee to gas main weld not properly cleaned – lack of fusion
- Supporting soil under the plastic gas main washed into the damaged sewer for many months

- Gas leak resulted when sagging gas main opened the defective weld
- Post-accident excavation work
 - Separated the service tee from the main
 - Cracked the branch outlet
- Water main cracked after the explosion
